## REQUEST FOR PROPOSAL, RFP # 16-08 ADDENDUM NUMBER 2

**DATE:** August 20, 2015  
**TITLE:** Purchase of the Old Blacksburg High School Property

**ASSESSMENT REPORT**  
**Attachment 'A'**  
**Blacksburg High School**

## Montgomery County Public Schools Facility Assessment - Blacksburg High School Floor Elevations Attachment 'B'

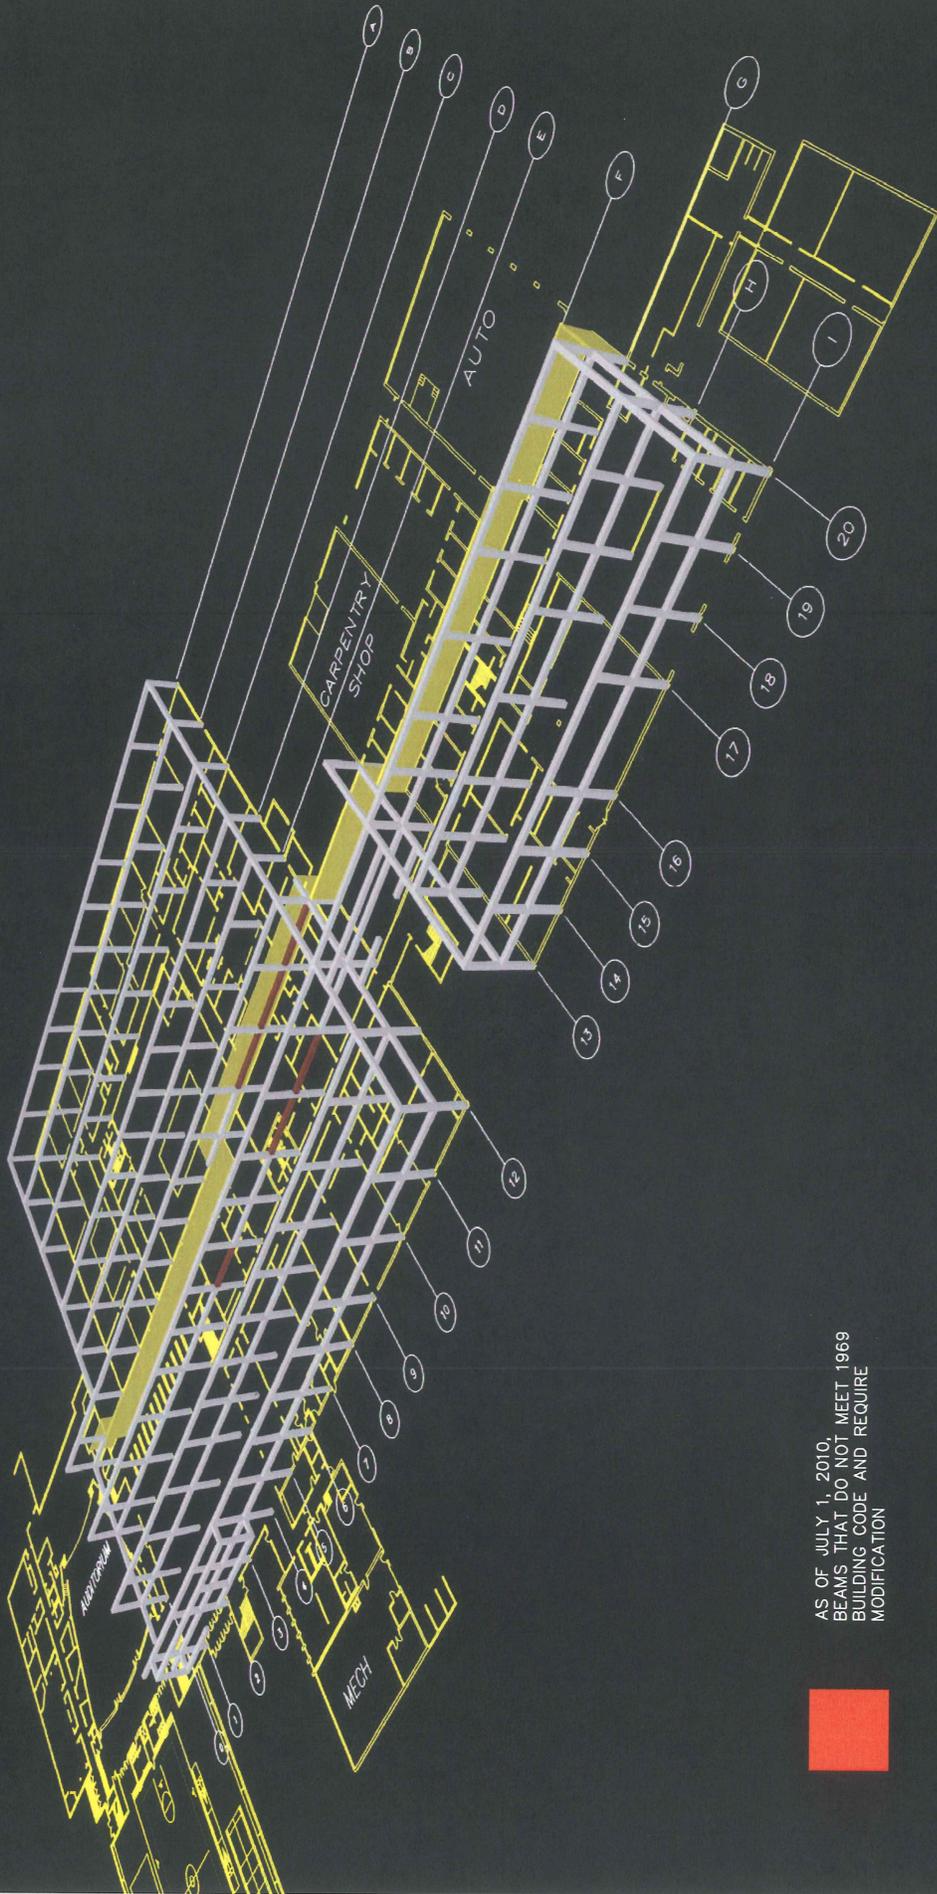
**Beam G10-G11:** Per the design documents available to us, the beam was supposed to be 48" wide x 20" deep with (11) #10 bars as bottom steel. As-built conditions were verified as 24" wide x 32 ½" deep with (6) #6 bars. OWPR's analysis indicates that the anticipated loading (per 1969 Building Code) exceeds the calculated mid-span capacity by 63%.

**Beam F9-F10:** We have a change proposal that states that the design was changed, but no description of the change. As-built conditions were verified as 24" wide x 19 ½" deep with (3) #6 bars and (4) #7 bars as bottom steel, then a second layer of (3) #6 bars just above the bottom steel. OWPR's analysis indicates that the anticipated loading (per 1969 Building Code) exceeds the calculated mid-span capacity by 116%. Following is a picture of the beam's bottom reinforcing steel after destructive testing was performed.

AS OF JULY 1, 2010,  
BEAMS THAT DO NOT MEET 1969  
BUILDING CODE AND REQUIRE  
MODIFICATION
